Technical Note N-1096

CORROSION OF DSRV MATERIALS IN SEA WATER - 12 MONTHS  
NATURAL EXPOSURE AND 98 CYCLES IN PRESSURE VESSELS

May 1970

NAVAL CIVIL ENGINEERING LABORATORY  
Port Hueneme, California 93041

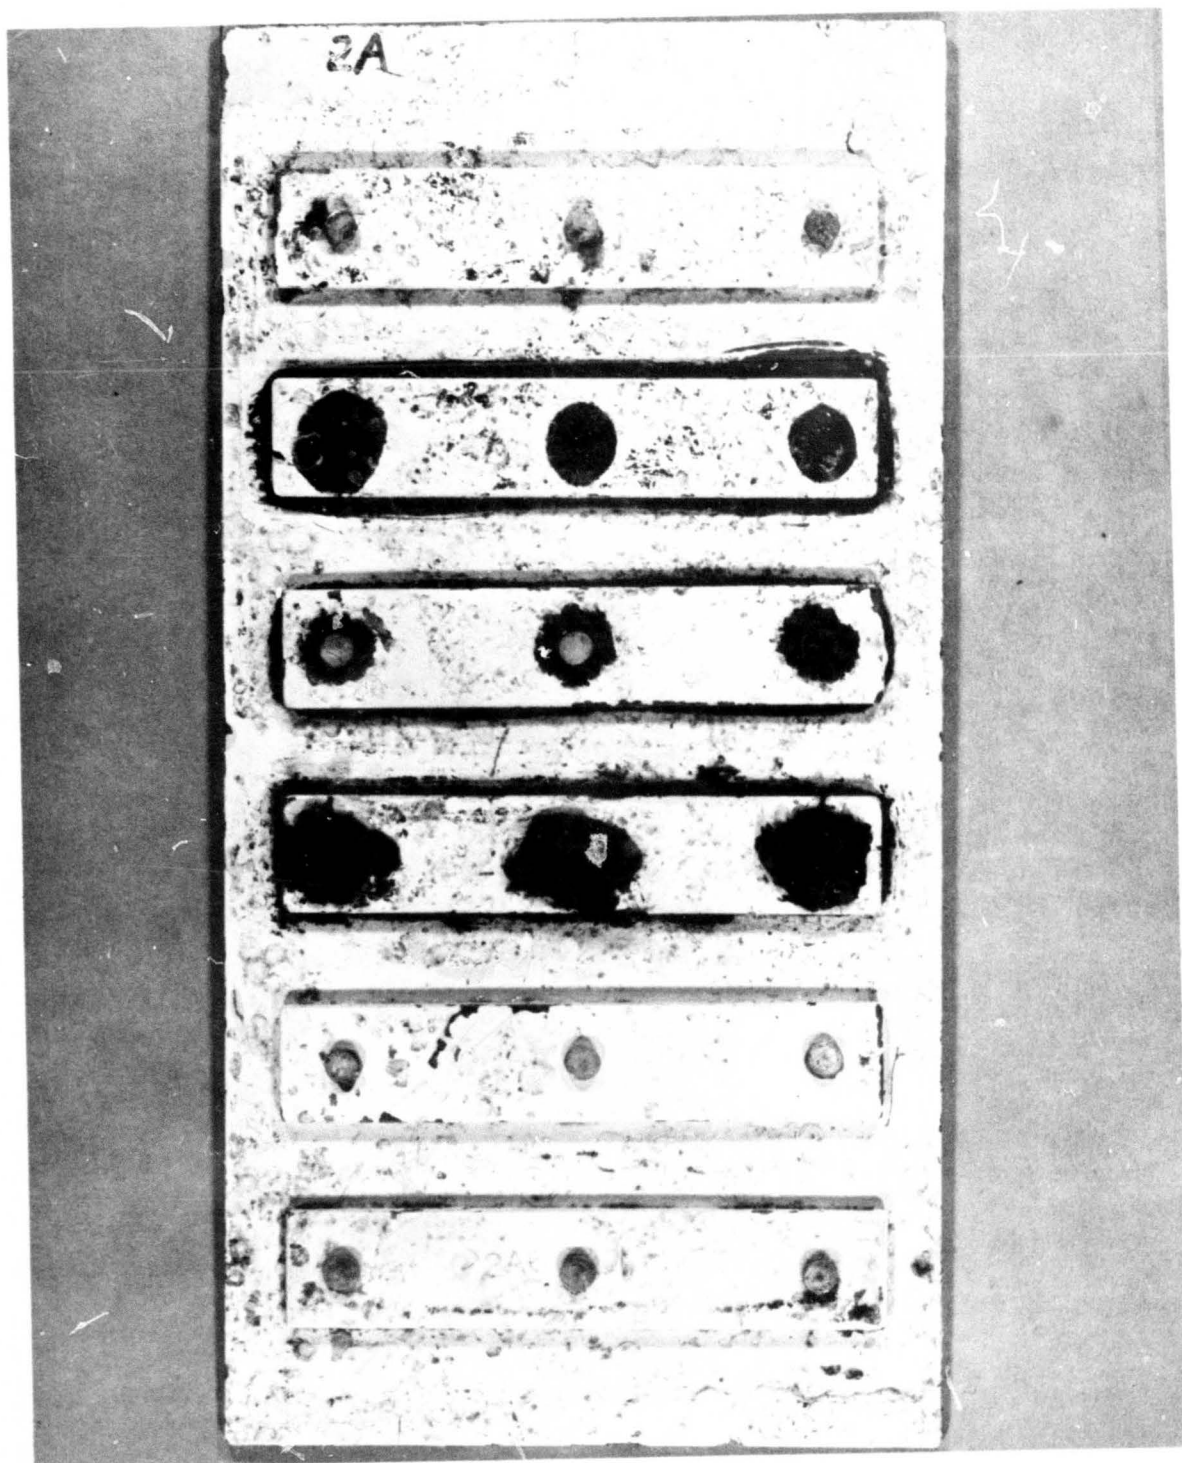
Figure 1. Exposed specimen showing general layout.

Specimens designed to evaluate the four areas of interest noted above were exposed at mean tide level at the Point Mugu site for a period of one year. The specimens were nominally 6x12 inches. Some of the specimens (the G-series) had 1x5-inch strips attached as shown in Figure 1. Sealants to be tested were applied at the faying surfaces between the panel and strips and on the heads of the fasteners. The types of fasteners used, the composition of the panel and strips, the paint coatings and sealants, where used, are given in the specimen descriptions in Table 1. At mean tide level the specimens are immersed in the sea water at high tide and exposed to the sea air at low tide. The geographical location and sea water characteristics at the Point Mugu site are:
